Manhole Inspection Summary

Manhole # S33Q__040MH

Insp Date: **3/14/08 8:06 AM**

Location Address: **114 hamburg**

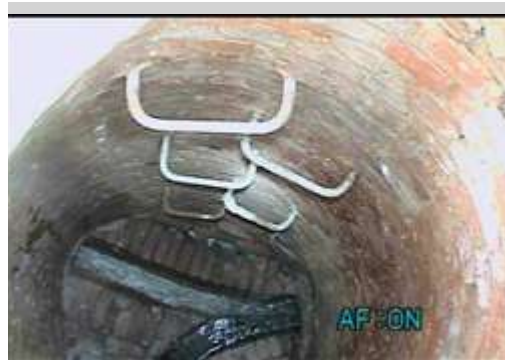
Defect 2

bench debris

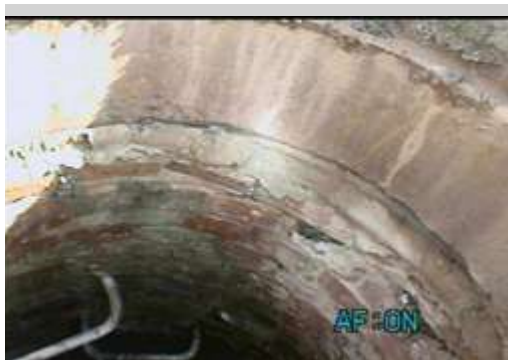
Defect 1

Condition: ☐ Sound ☐ Cracked ☐ Root Intrusion ☐ Loose Brick ☒ **Deteriorated**

Chimney deteriorated
frame adjustment

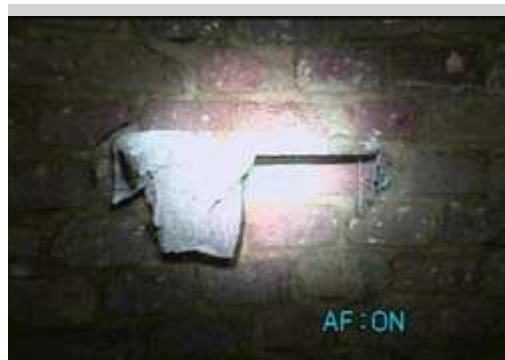
Defect 4

☒ **Evidence Of Surcharge** Depth: **3.4** (ft.) ☐ Active Surcharge Present

evidence of surcharge

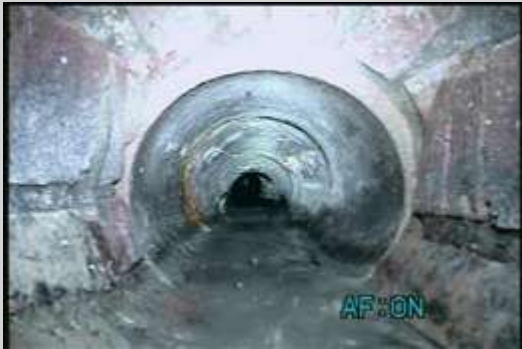
12 O'Clock Outflow

8 in. Circular Gravity Sewer
Pipe Out @ 12 O'Clock

Invert Depth: **10.33** (ft.) Flow Characteristics: **Fast**

Infiltration: **None** Pipe Seal Cond: **Unknown**

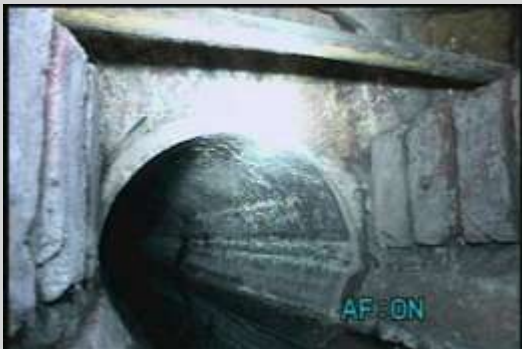
4 O'Clock Inflow

8 in. Circular Gravity Sewer
Pipe In @ 4 O'Clock

Invert Depth: **10.16** (ft.) Flow Characteristics: **Slow**

Infiltration: **None** Pipe Seal Cond: **Unknown**

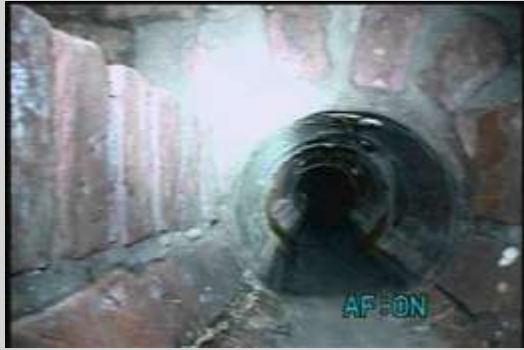
7 O'Clock Inflow

8 in. Circular Gravity Sewer

Pipe In @ 7 O'Clock

Invert Depth: **10.00** (ft.) Flow Characteristics: **Fast**

Infiltration: **None** Pipe Seal Cond: **Unknown**
